DNA 4369F

**HARDENED RV DEVELOPMENT PROGRAM
PHASE III
SAMS/TATER Heatshield/Antenna
Window Flight Test Program**

February 1977

Final Report for Period 3 November 1975–30 September 1976

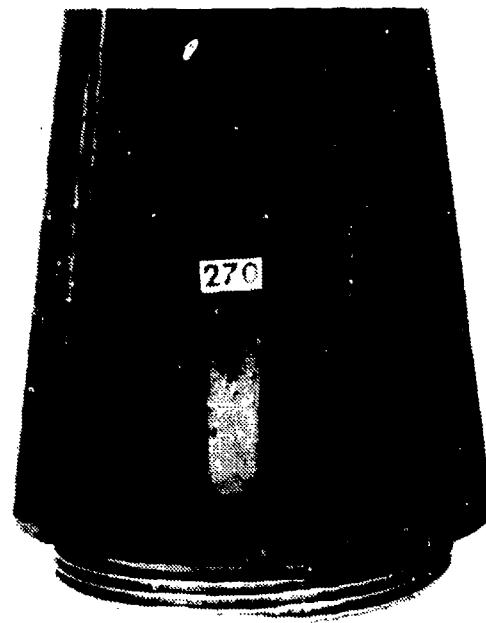
Figure 37. Post-Flight TS-1251 in 2DCP20°,
0° Quadrant

Figure 38. Post-Flight TS-1251 in 2DCR-10
20°, 90° Quadrant

Figure 39. Post-Flight TS-1251 in 2DCP20°,
180° Quadrant

Figure 40. Post-Flight TS-1251 in 2DCR-10
20°, 270° Quadrant

Loss of the hot-pressed boron nitride (UCC TS-1251) antenna windows was probably due to thermal stress cracking of the material early in the flight. The low strength, relative brittleness, and apparent thermal stress sensitivity of TS-1251 severely limit the use of this material for flight antenna window applications.
